Supplemental Report

Bryson v. Rough Country, LLC

Mecanica Case Number: 22-3104

Date of Collision: March 15, 2020

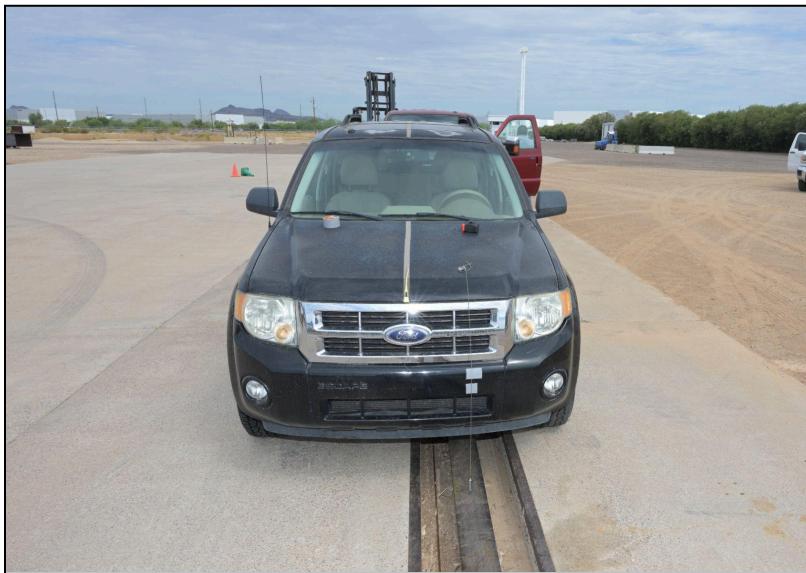
Figure 53: Front of an exemplar Escape with the crash rail centerline 10.9 inches left of Escape's longitudinal centerline.

Exemplar vehicles were also lined up to replicate the crash test alignment. The Escape was first aligned on the crash rail. Measurements were taken from the longitudinal centerline of the Escape 10.9 inches to the left on the front and rear bumpers. These points were then aligned with the crash rail centerline (**Figures 53 and Figure 54**). The front of the F-250 was then moved to the rear of the Escape, with the F-250's longitudinal centerline aligned with the crash rail centerline (**Figure 55**). In this configuration, the F-250's longitudinal centerline was just inside the left rear-window hinge (**Figure 56**).

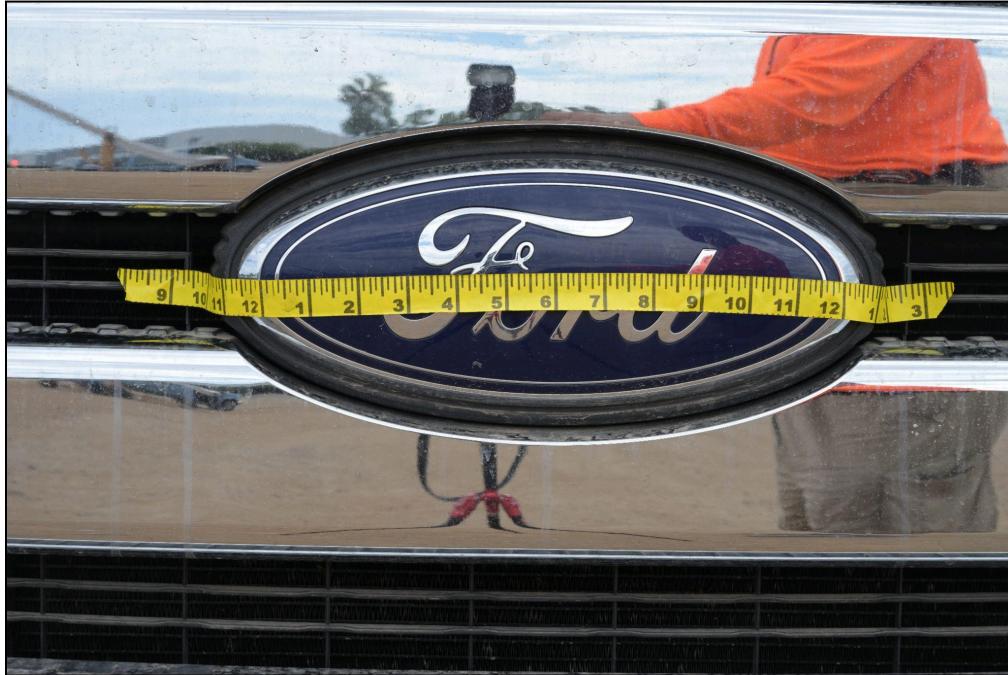
Figure 57: Width of the Ford logo on the F-250

The Ford logo at the front of the F-250 was approximately 12 inches wide, from one outer edge of the blue border to the other, shown in **Figure 57**. The center of the logo was six inches from either outer edge of the blue border. In other words, the '6' on the inch tape is the approximate middle of the logo shown in **Figure 57**.

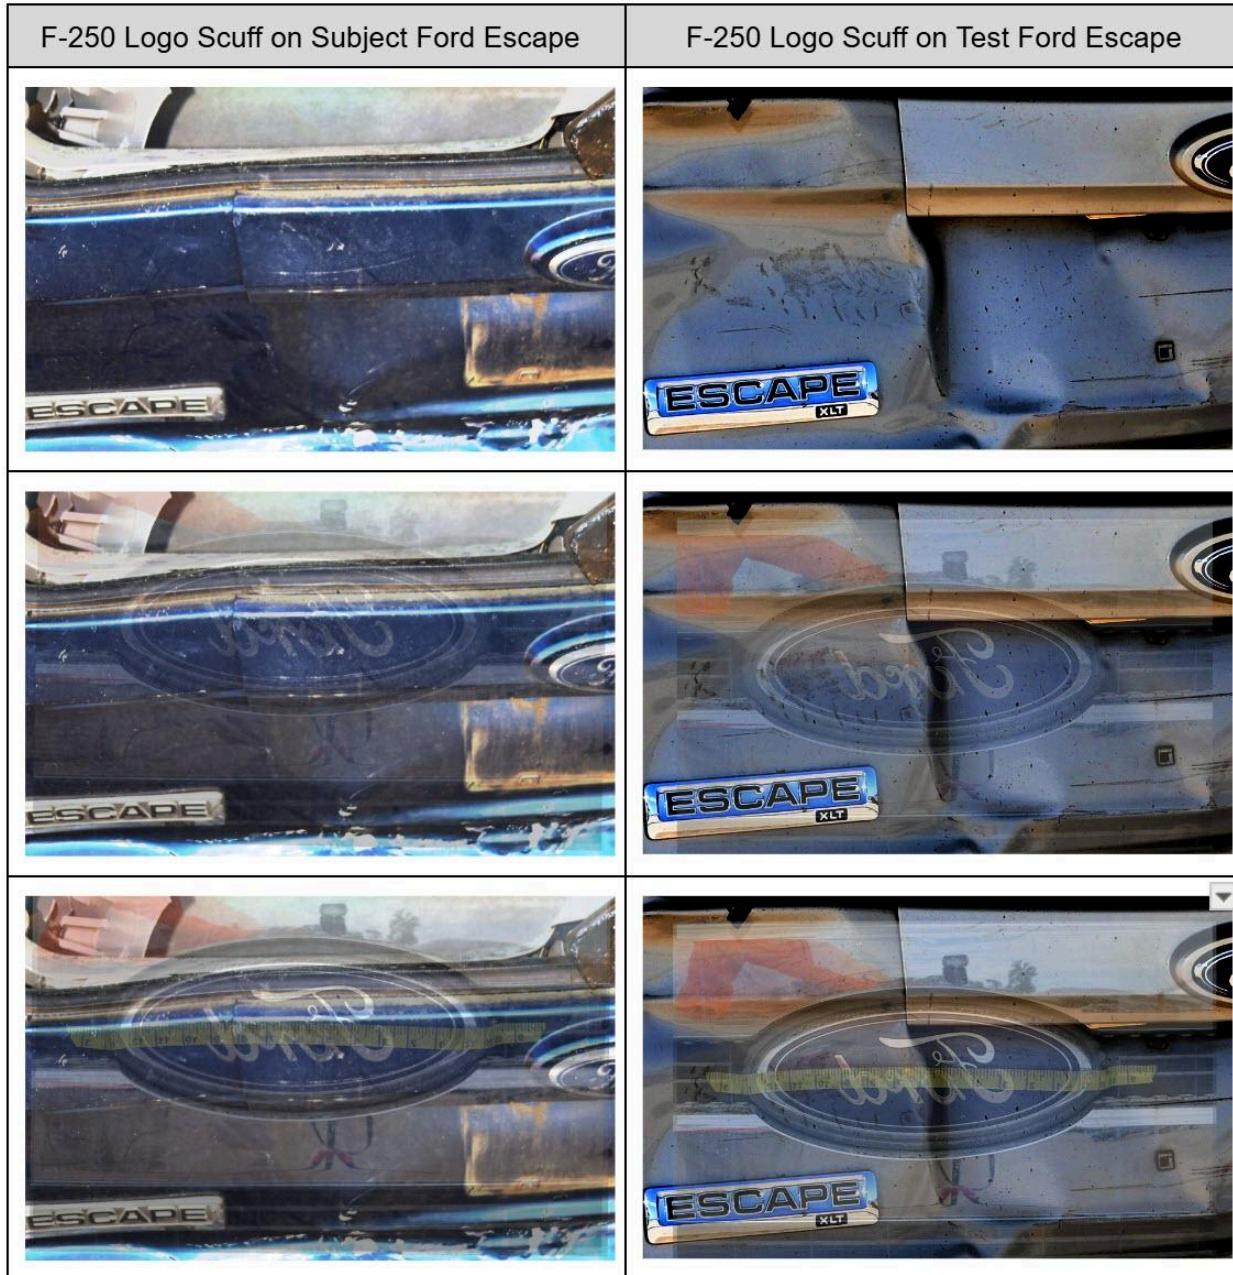
There were impressions, or scuffs, from a Ford F-250 logo on the Ford Escape from the subject crash as well as the Ford Escape used in the crash test. There was a trim panel on each Ford Escape located in the middle of the hatchback at the glass line, and the lower-left corner of this panel was used as a reference point on each vehicle to identify where the logo scuff was located.

There is no way to determine exactly when this logo impression was created during the interaction between the vehicles. They were not created at the initial point of impact since the F-250's front bumper would first contact the Escape. Also, note that these are complex 3-dimensional surfaces and 2-dimensional photos cannot place these marks more accurately than approximately a $\frac{1}{4}$ (0.25) inch. **Figure 58** depicts photos from both vehicles and the progression of images including the following:

Figure 58: Image overlays depicting F-250 logo scuff on Ford Escape.

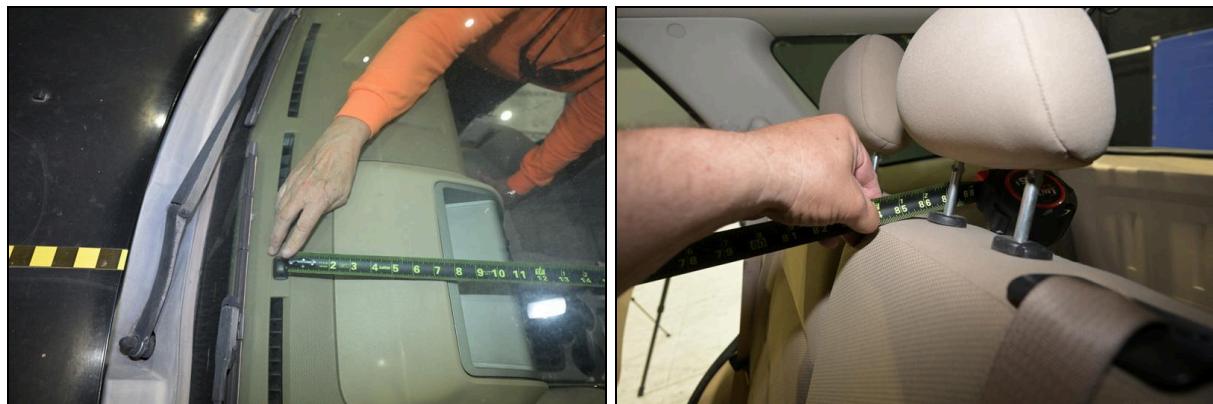
Figure 64: Measurement to upper middle of rear seatback in exemplar Ford Escape.

A measurement was made from the daylight sensor, located in the top middle of the dash, to the middle top of the rear seatback. The reference point on the rear seatback was a black plastic trim around the right headrest post. **Figure 64** depicts this measurement in the exemplar vehicle and **Figure 65** depicts this measurement in the test Ford Escape. This part of the rear seatback was displaced forward approximately 10 inches.

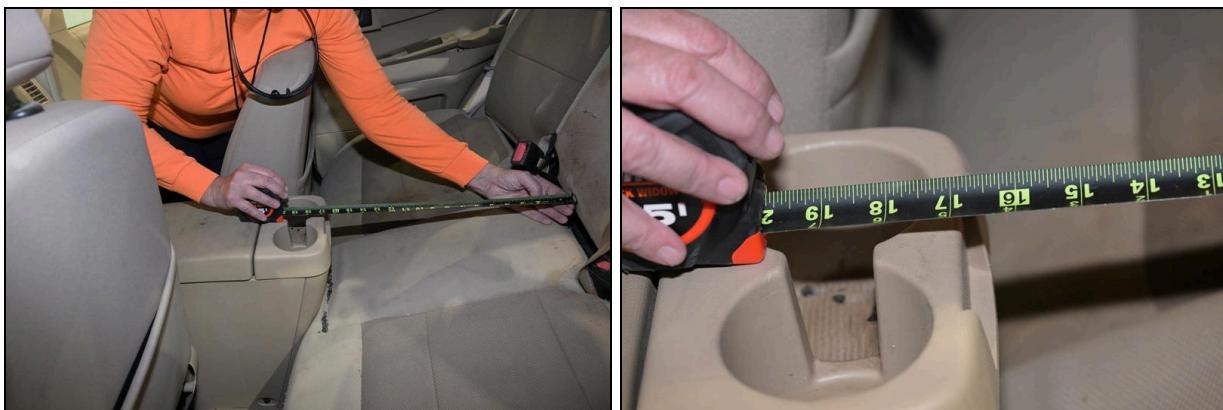
A measurement was made from the aft edge of the center console to the lower middle of the rear seatback. **Figure 66** depicts this measurement in the exemplar Ford Escape and **Figure 67** depicts this measurement in the test vehicle. This part of the rear seatback was displaced forward approximately 10.5 inches. Note that this measurement also includes more of a vertical component in the exemplar vehicle, thus the actual displacement would be slightly less.

Figure 67: Measurement to lower middle of rear seatback in test Ford Escape.

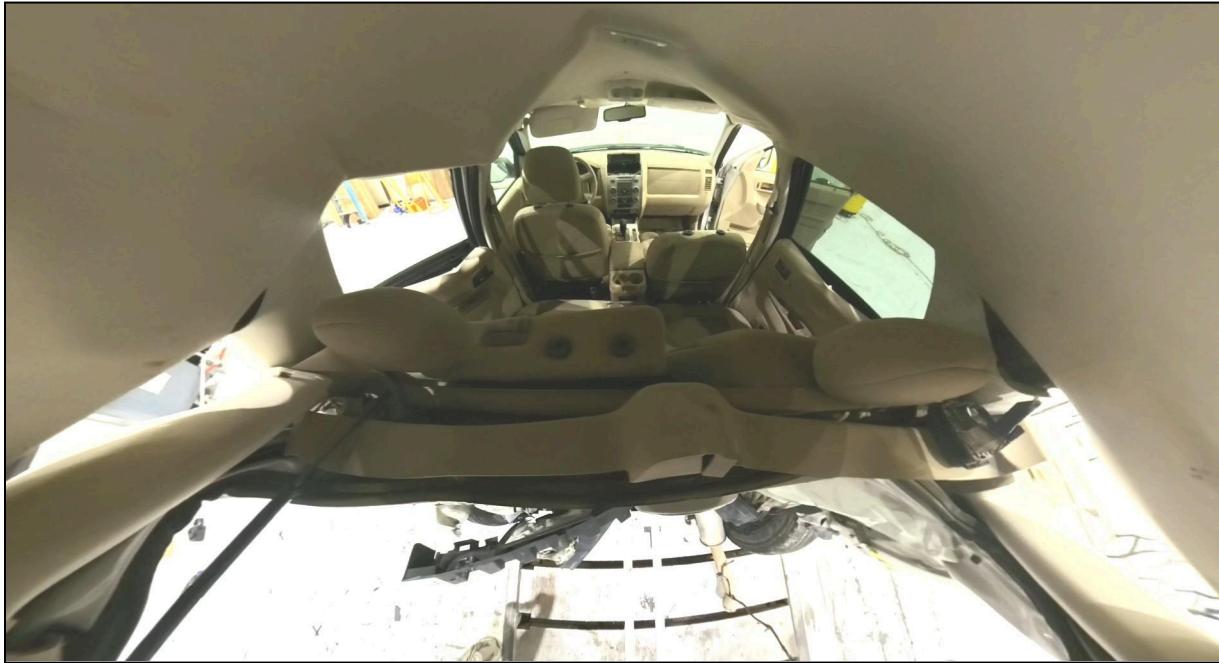
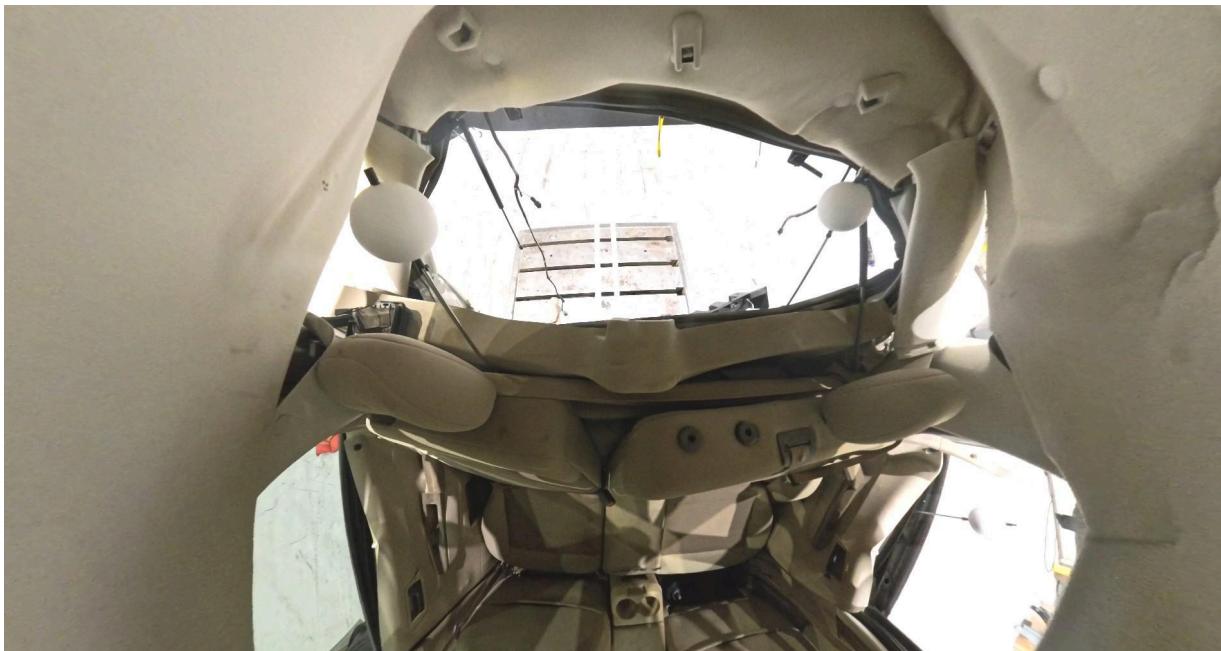
Figure 68 through Figure 70 depicts still images extracted from a 360 video of the seatback area of the test Ford Escape. It can be seen that the seatback is displaced and distorted. In addition, these images show that the interior of the vehicle hatch made contact with the aft portion of the rear seatback.
